# Manhole Inspection Summary

Manhole # S23OO1020MH

Insp Date: **11/7/06 2:25 PM**

**Location** Address: **212 RIDGEWOOD RD**

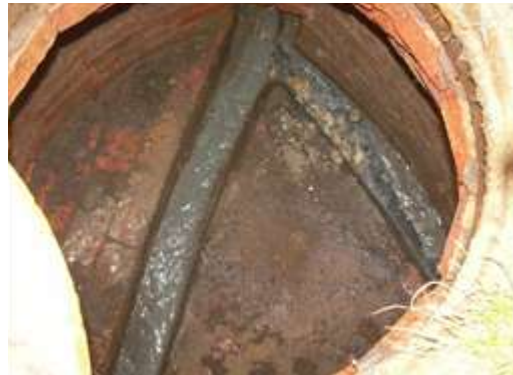
Top View

Adjustment and Barrel infiltration. Bench and Channel debris.

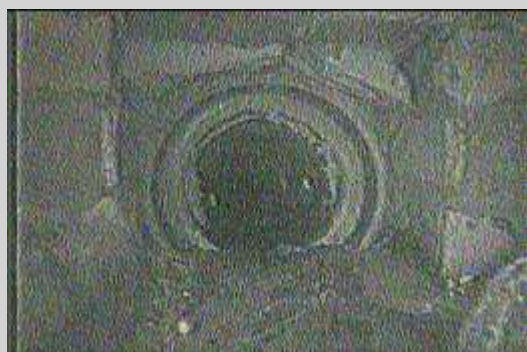
Pipe Out @ 12 O'Clock

Pipe Seal Cond: **Cracked**

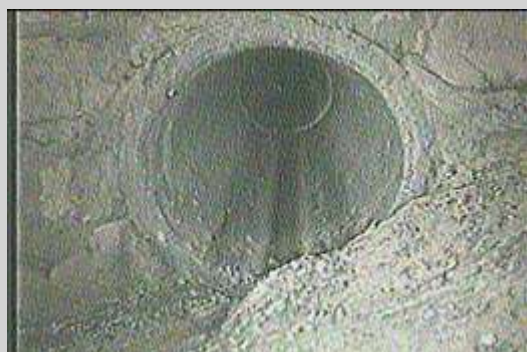
Pipe In @ 3 O'Clock

Infiltration: **Evidence**

Pipe Seal Cond: **Cracked**

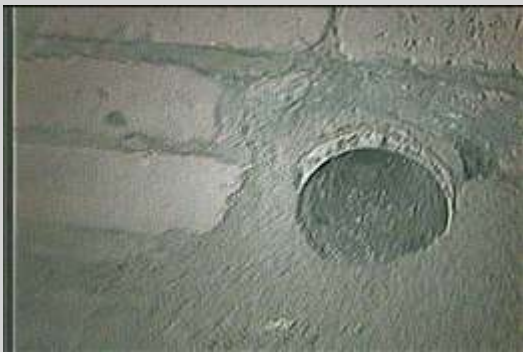
Pipe In @ 8 O'Clock

Deposits: ☐ None ☒ **Mud** ☐ Sludge ☒ **Debris** ☐ Grease

Silt Depth: **0.5** (in.) Deposits Extent: **Light**
